Effects of a major earthquake near Bougainville, 20 July 1975

I. B. Everingham, B. Gaull, & V. Dent

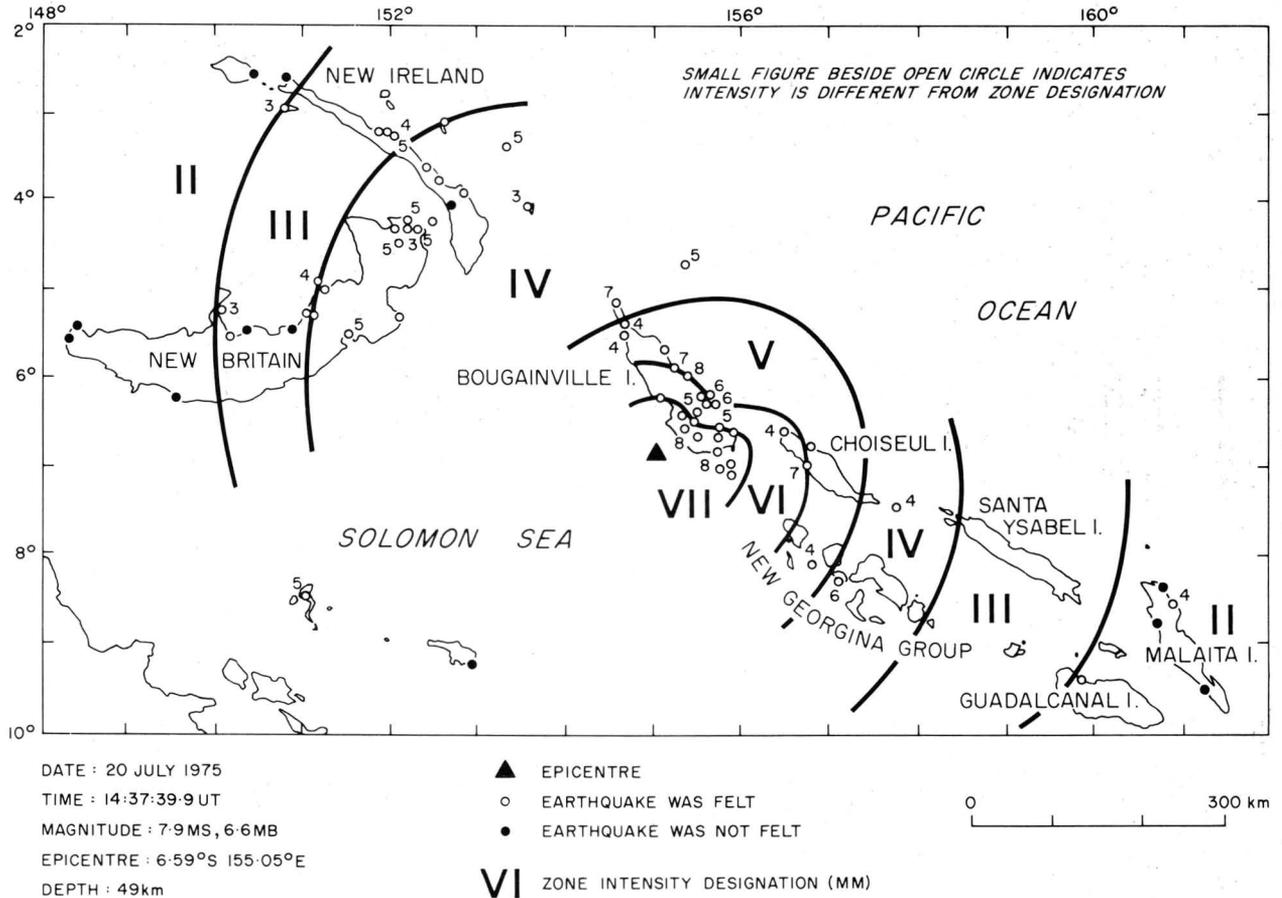
Figure 6 shows that intensities vary over fairly short distances, e.g. at about 6°S on the east Bougainville coast where intensity ranges from MMV to VIII. This could result from the manner in which the questionnaires were answered, but it is considered that the effect is more likely to be real and result from differences in the foundation subsoil and the topography. The tendency for mountain ridges to be shaken more strongly than flat areas and sites in valleys in Papua New Guinea had frequently been observed, and the effect has been proven instrumentally by accelerographs (Everingham, 1973; Gaull, 1976).

The earthquake was felt clearly (MMIV or greater) as far afield as Rabaul and Losuia, about 500 km from the epicentre. Although Bougainville Island was shaken with intensities of MMV or more, significant damage was restricted to the southwestern region of the island, where intensities of MMVII or greater were experienced, and the Panguna mining area, where local intensities were MMVI to VII. The northernmost Solomon Islands, e.g. Shortland Island, lying close to the epicentre were also subjected to high intensities.

In the area with intensities of MMVII or more, landslides were common, bridges were damaged, roads cracked, and people had difficulty in standing during the earthquake. Concrete masonry structures lacking reinforcing, weaker village homes, and a considerable proportion of circular corrugated-iron water tanks were badly damaged. Structures not fastened securely to their stumps were shaken off them, and wharves, particularly their approaches, were damaged. Subsidence of areas along the coastlines were also noted in the region of these high intensities.

Figure 6. Isoseismal map for 20 July 1975 earthquake.

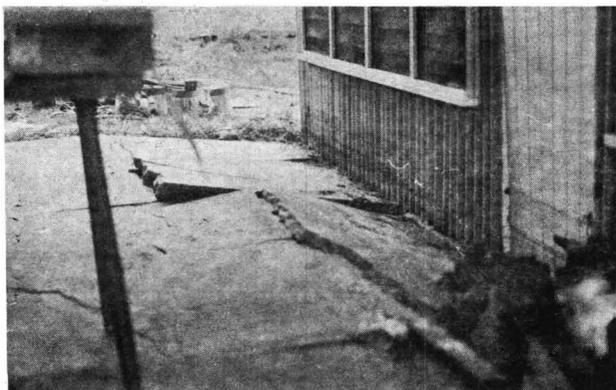
Figure 7. P & T power station at Torokina. Note subsidence of building carrying heavy machinery.

In the Department of Posts & Telegraphs (P & T) communications station at Torokina water marks were visible on walls. Inside the main building the marks were fairly straight. On the outside of this building the top water mark at 1.14 m was irregular. Straight water marks were left at various levels as the water receded (Fig. 7).

Subsidence of the P & T buildings (Figs. 7 and 9) probably took place during the main earthquake, but before the tsunami. However, further subsidence occurred during strong aftershocks, notably those about 0930 and 1230 local time on 21 July. During the latter earthquake, engineering staff who had flown in to repair the station reported that the tower base swayed over an estimated range of 400 mm, and that liquefaction of the ground occurred. Liquefaction in the vicinity was also shown by the movement of the wharf piles (driven down to a depth of about 14 m), which now slope out towards the sea at an angle of about 10-15° from the vertical (Fig. 10), and by the fact that heavy objects tended to sink while light objects, such as buried empty petrol drums, rose out of the ground. Old buried piles of a discarded World War II landing wharf emerged after the largest aftershock (Fig. 11).

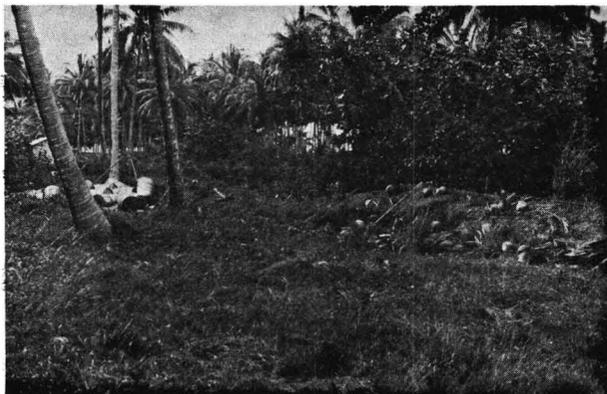
Figure 8. P & T station, Torokina. Petrol drums and debris washed inland and piled against wire-mesh fence.

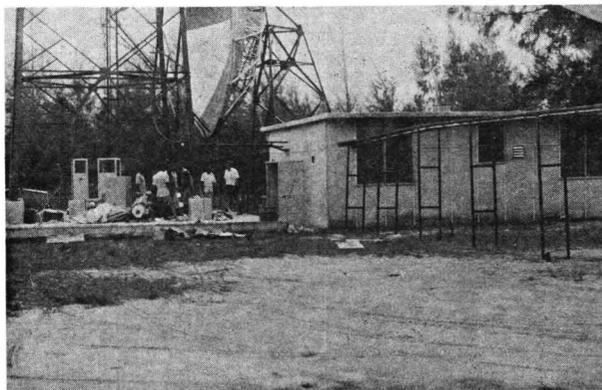
The communications station at Torokina (Fig. 9) consists of a 38 m tower for a dish aerial, two further dish aerials on about 10 m towers, an electronics building adjoining the main tower, a power house, and a residence. All the buildings are sited about one metre above high-tide level, close to the sea, on land which has been built up naturally since World War II—i.e. the coast was inland from the station some 30 years ago.

Figure 9. P & T station, Torokina. Equipment building on right subsided 250 mm. Tower and platform on left did not subside being based on deep piles. Sand in foreground was ejected by aftershocks.

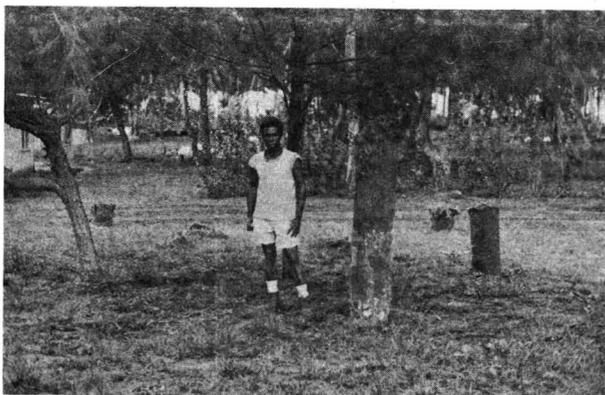
Figure 11. Old wharf piles at Torokina extruded by effects of liquefaction caused by aftershocks. Tops of piles were formerly below ground level as evidenced by plants growing on them.
