Tsunami Waves in Izmit Bay

Kocaeli, Turkey, Earthquake of August 17, 1999 Reconnaissance Report

3 Tsunami Waves in Izmit Bay

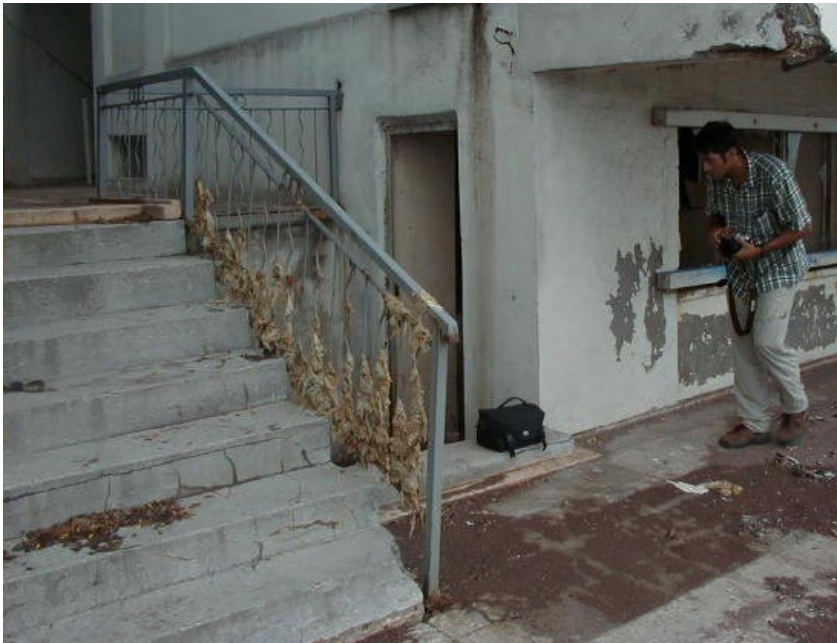
Tsunami run-up measurements were taken using watermarks and seaborne debris (see figure 3.1). Run-up refers to the elevation difference between the most inland penetration point of the wave and the shoreline, at the time of the event (Synolakis et al. 1995; Kawata et al. 1999). When it is impossible to measure run-up directly, the elevation difference between watermarks and the shoreline is used as a substitute. The two are seldom identical, and the former is usually smaller than the latter. During the Kocaeli field survey, more than one hundred eyewitnesses were interviewed. The surveys were performed at the locations shown in figure 3.2 and listed in table 3.1 (Altinok et al. 1999). Overall the tsunami damage was small but quite extensive in area.

Figure 3.1. The tsunami wave left behind seaborne debris (seaweed) hanging on the staircase railing at Kirazliyali (location 8 in figure 3.2).

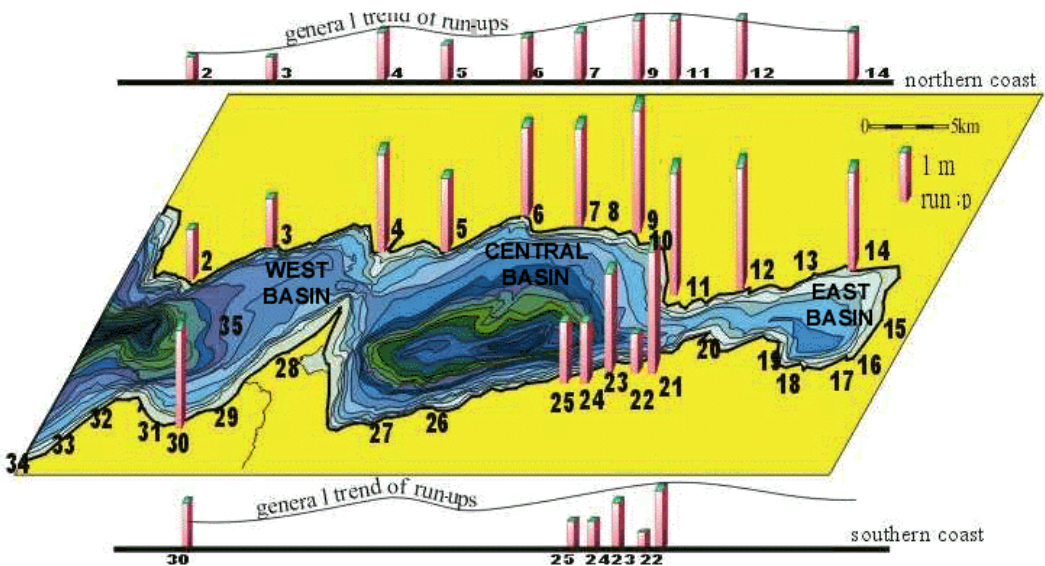
As shown in figure 3.2, along the northern coast of Izmit Bay, in the central basin between

Figure 3.2. Bathymetry of Izmit Bay, locations of tsunami field surveys, and measured values of run-up heights (Altinok et al. 1999).

Hereke and Tupras industrial plant, the tsunami had the form of a leading depression wave. These waves, which were first described by Tadepalli and Synolakis (1994 and 1995), caused transient exposure of the seafloor near the shoreline. It is now common knowledge that most near-shore tsunamis manifest themselves as leading depression waves, also referred to as LDNs. The run-up heights ranged from 1.5 to 2.6 meters and decreased to high-water levels within 4 km east of Tupras and 10 km west of Hereke. The first wave arrived along the north coast a few minutes after the earthquake and had a period of about one minute. The sea withdrew during the earthquake in the port at Tavsancilar, and the elevation wave that followed flooded up to 25 meters inland and invaded the first floor of houses (see location 5 in figure 3.2). Henceforth the location numbers refer to the vertical bars in figure 3.2.

The hardest hit areas were Sirinyali, Kirazliyali, Yarimca, Korfez, and Tupras (locations 7 to 11). The basements of waterfront apartments were flooded, and the sea rose to the second floor of some houses near Kirazliyali. The wave carried mussels into houses and damaged doors and windows. At the Yarimca Yachting Club (location 9), the sea first receded 15 to 20 meters, and the following elevation wave lifted up a motor yacht and moved it 50 meters inland. A second wave inundated the same shore to 30 meters inland. At Korfez, the inundation distance ranged up to 35 meters. There were clear watermarks on the wall of the police station in Hereke (location 6) and at the Denizkosku restaurant in Korfez. Eyewitnesses reported that the wave arrived at Kirazliyali from the southeast and at Korfez from the south. At the Izmit Marina (location 14), the sea receded about 40 meters. At Seymen (location 17), the waves were observed to come from the northwest.

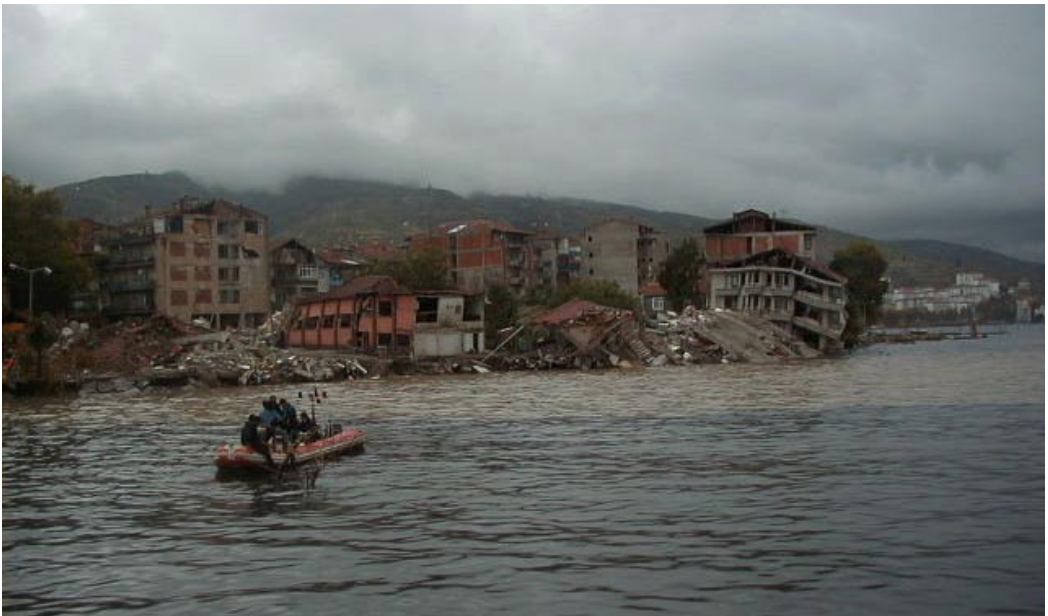
Figure 3.3. At Cinarlik Park near Degirmendere (location 21 in figure 3.2.), a hotel, restaurants, shops, and trees along the shoreline subsided into the sea, at the place where the seawater changes to a lighter color. The divers on the boat were looking for a car dragged into the sea by the wave.

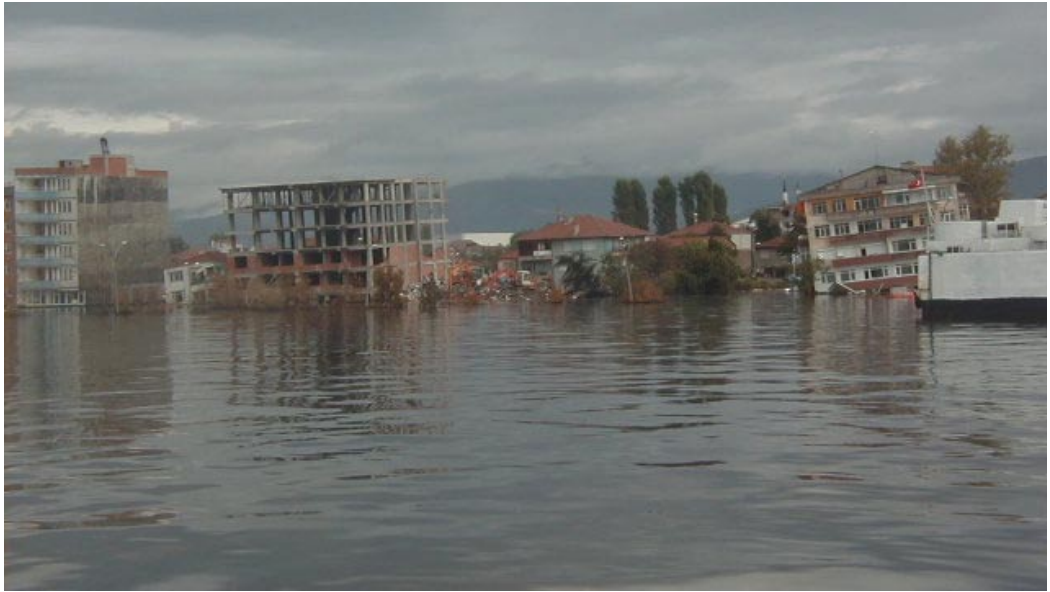
Figure 3.4. A view from the sea of the subsided coastal area at Kavakli, west of Gölçük (location 20 in figure 3.2).

(location 19, figure 3.3) along the southern coast up to Güzelyali. The wave was noticed immediately after the earthquake. As shown in figure 3.4, there was significant coastal subsidence in addition to slumping of Cinarlik Park near Degirmendere (location 21). The subsided area extended 250 meters along shore and 70 meters perpendicular to shore and included two piers, a hotel, a restaurant, a coffeehouse, and 14 large trees. The sea was observed receding about 150 meters in less than 120 seconds near Degirmendere. When the sea came back, it flooded up to 35 meters inland, as indicated by the mussels and dead fish left in this inundation area.
