Surface deformation during the Mw 6.4 (8 June 2008) Movri Mountain earthquake in the Peloponnese, and its implications for the seismotectonics of western Greece

Article in *International Geology Review* · February 2010

The Movri Mountain earthquake (Mw 6.4), western Greece, was likely caused by dextral-slip along a blind high-angle fault, and generated a complex pattern of co-seismic surface ruptures southwest of the Gulf of Corinth. The mapped Nisi, Michoi, and Vithoukas rupture segments have similar lengths (5–6 km) and vertical offset on the order of 25, 10, and 5 cm, respectively. They are commonly expressed as straight or jagged linear traces with secondary cracks radiating from the main segments. Horizontal slip vector analysis indicates extensional faulting processes for all rupture segments. Although these faults exert some control on the fluvial drainage pattern and at least one of them was ruptured during past events, their escarpments are poorly preserved. The indistinct topographic expression of the studied faults and their complex rupture patterns can be attributed to the distribution of the deformation over a blind fault.

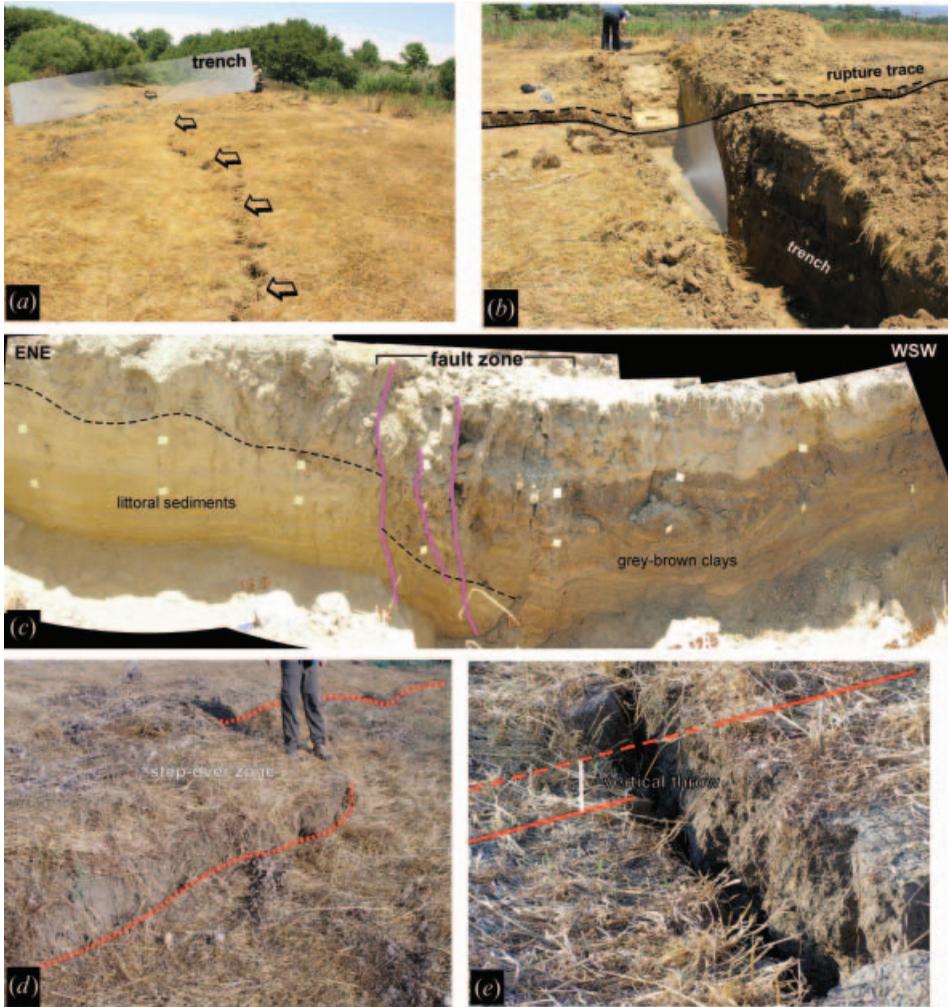
Figure 4. Details of the Nisi fault rupture. (a) Photo of the NNW-trending surface rupture showing also bulging of the footwall (right half of the photo) and warping of the hanging-wall block toward the fault plane. The position of the excavated trench is also shown. Photo was taken looking northwest. (b) General view of the palaeoseismological trench excavated across the Nisi fault. (c) Detailed view of the palaeoseismological trench after cleaning and gridding. Note the 1-m wide fault zone comprising several fault strands with some of them characterized by open voids, caused from the last earthquake event. The footwall of the fault occupies yellowish littoral sediments while the hanging wall comprises grey-brown clays. (d) Detailed view of the surface ruptures showing a step over zone. (e) Detail of the surface rupture showing 25 cm vertical throw (white bar) and 10 cm aperture.

segments. Significant vertical displacements, up to 25 cm (Figures 4 and 5(b)), have been identified along this high angle NNW-striking segment.

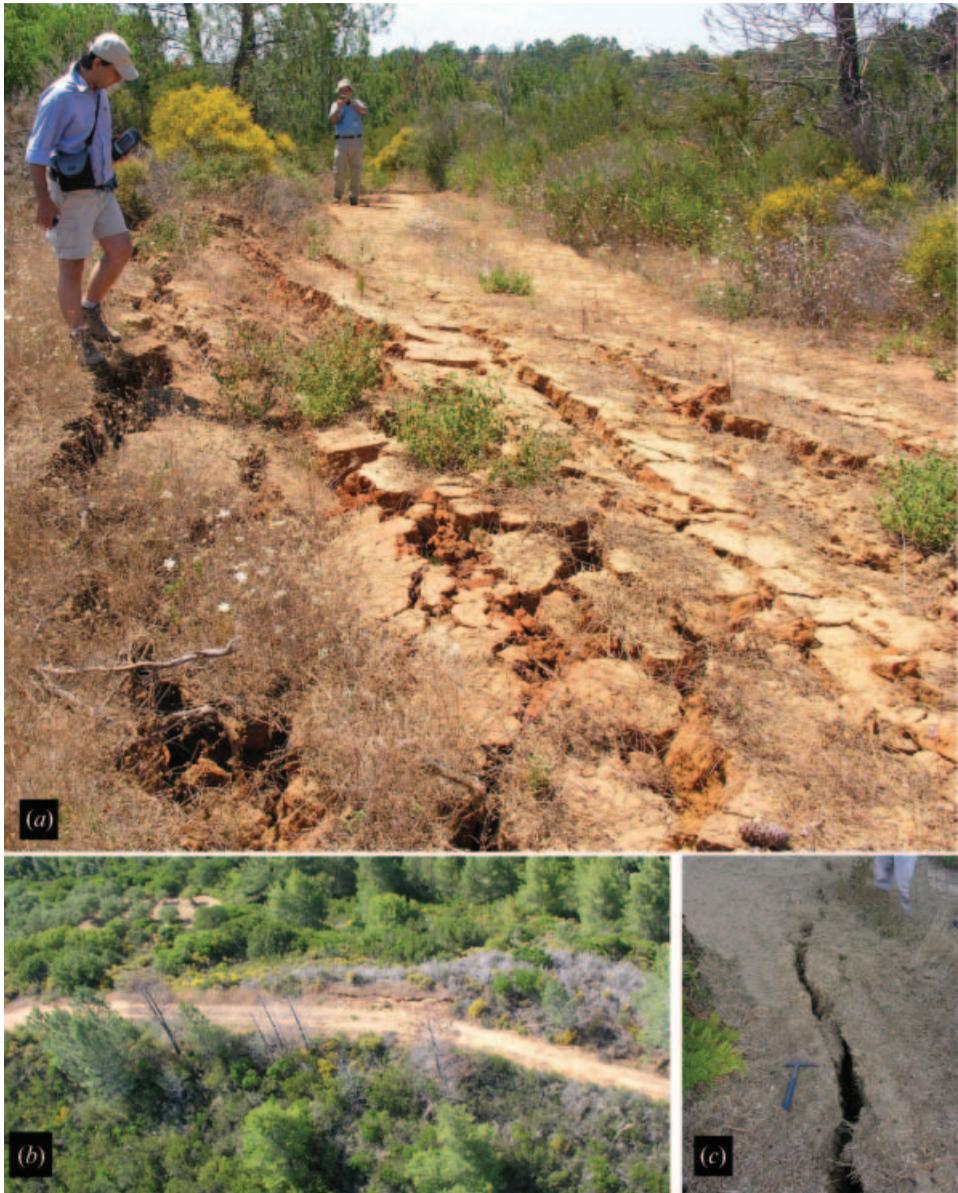
Figure 6. Key outcrops of the surface rupture along the Michoi fault. (a) A 3-m-wide zone of surface ruptures mapped on 11 June 2008, showing step-type geometry of faulting in the north half of the photo and a graben in its central part. Photo is taken looking west, location 1 km south of the epicentre and west of Michoi village. (b) Helicopter view of the Michoi surface rupture 0.8 km west of Michoi village. (c) Detail of the WNW-trending surface rupture close to Dafni Village (for location see Figure 2).
