Macroseismic Intensity Map  
 USGS ShakeMap: 15 km E of Kirkağaç, Manisa, TR  
 Jan 22, 2020 19:22:16 UTC M5.6 N39.08 E27.85 Depth: 8.6km ID:us60007d2r

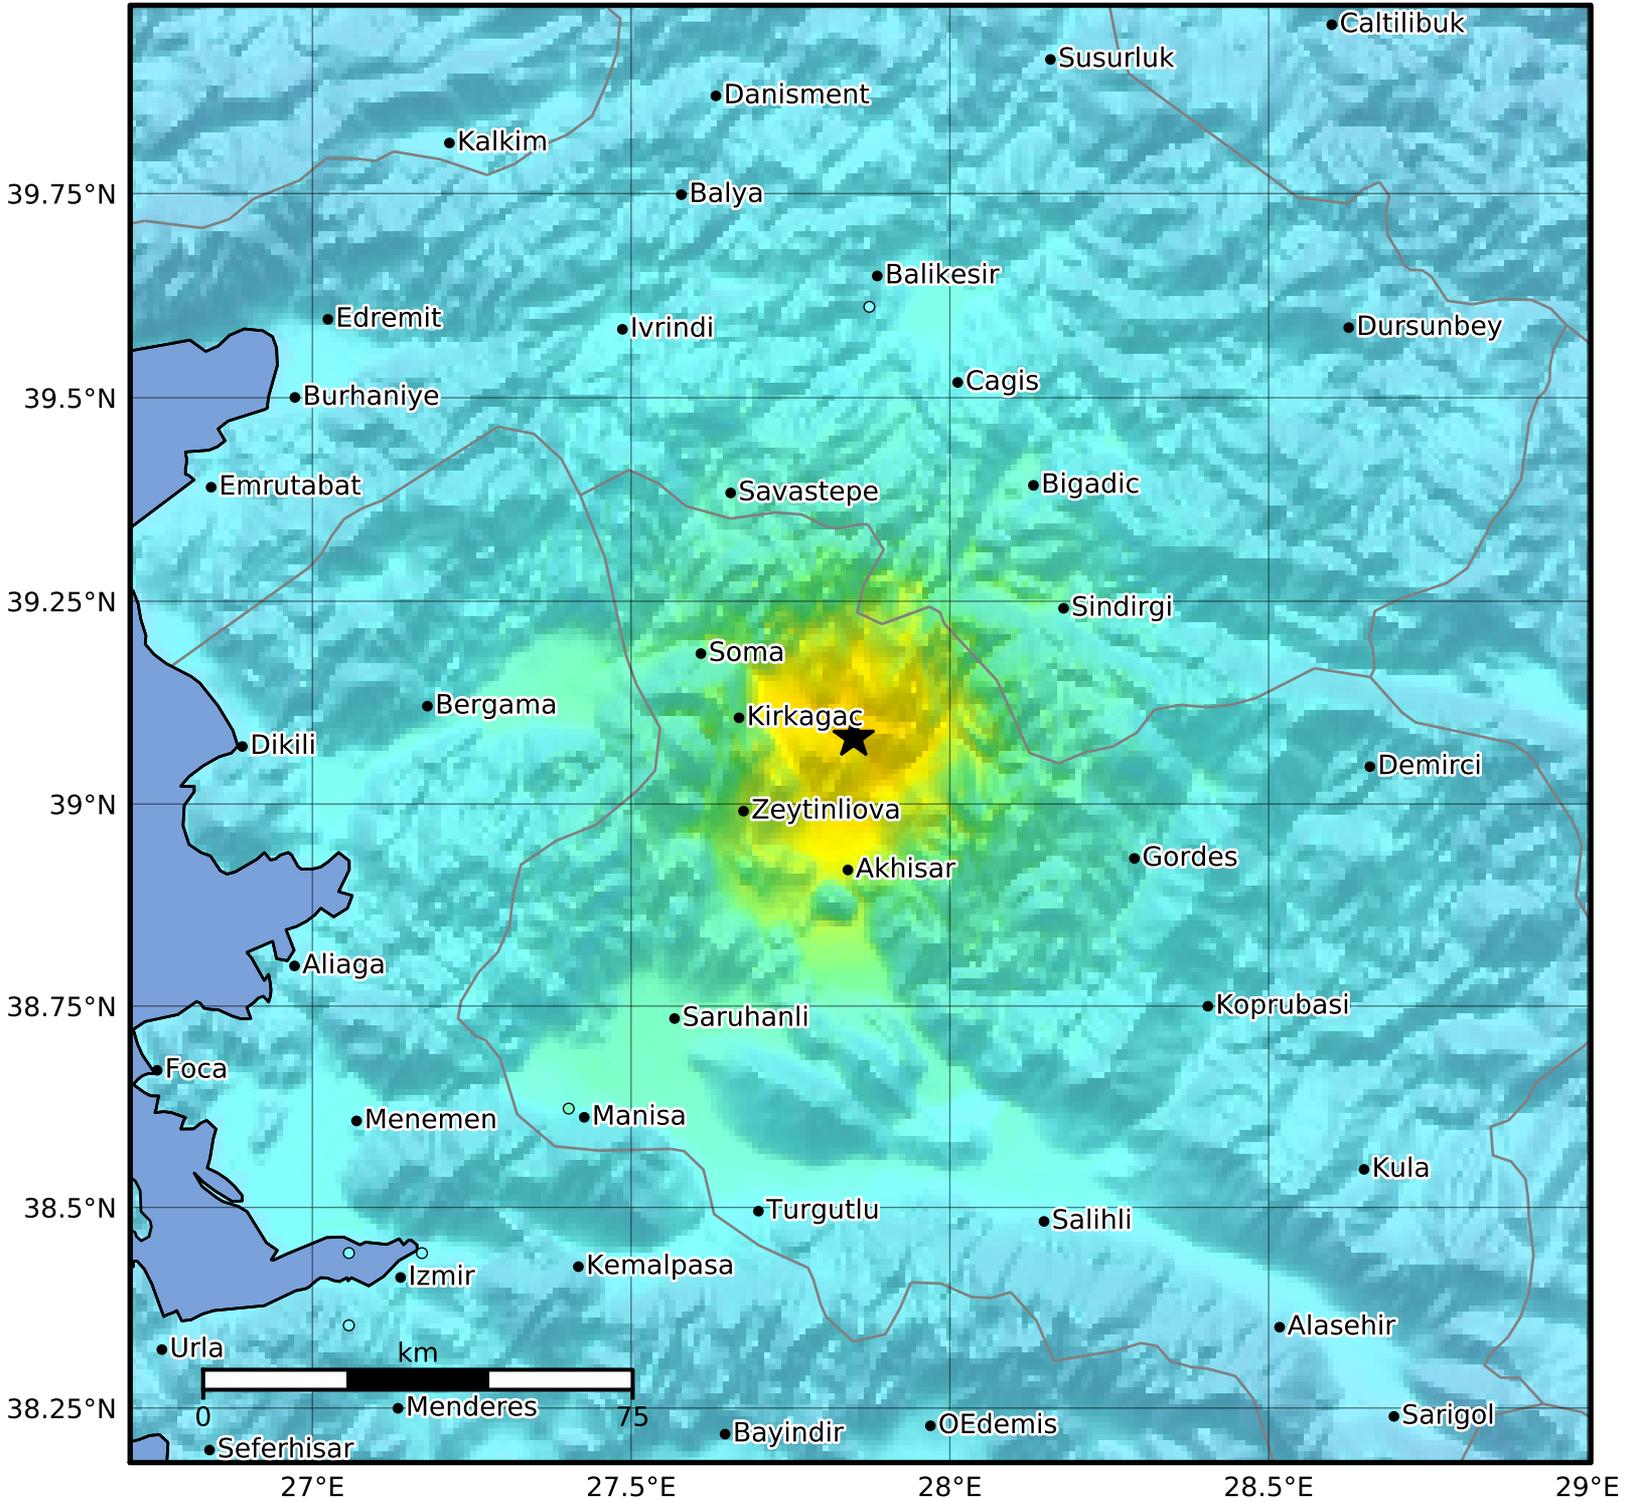
SHAKING	Not felt	Weak	Light	Moderate	Strong	Very strong	Severe	Violent	Extreme
DAMAGE	None	None	None	Very light	Light	Moderate	Moderate/heavy	Heavy	Very heavy
PGA(%g)	<0.05	0.3	2.76	6.2	11.5	21.5	40.1	74.7	>139
PGV(cm/s)	<0.02	0.13	1.41	4.65	9.64	20	41.4	85.8	>178
INTENSITY	<b>I</b>	<b>II-III</b>	<b>IV</b>	<b>V</b>	<b>VI</b>	<b>VII</b>	<b>VIII</b>	<b>IX</b>	<b>X+</b>

Scale based on Worden et al. (2012)

△ Seismic Instrument ○ Reported Intensity

★ Epicenter
