California Geological Survey Tsunami Event Response Program: Tonga Tsunami 2022

Tsunami and Impact Observations

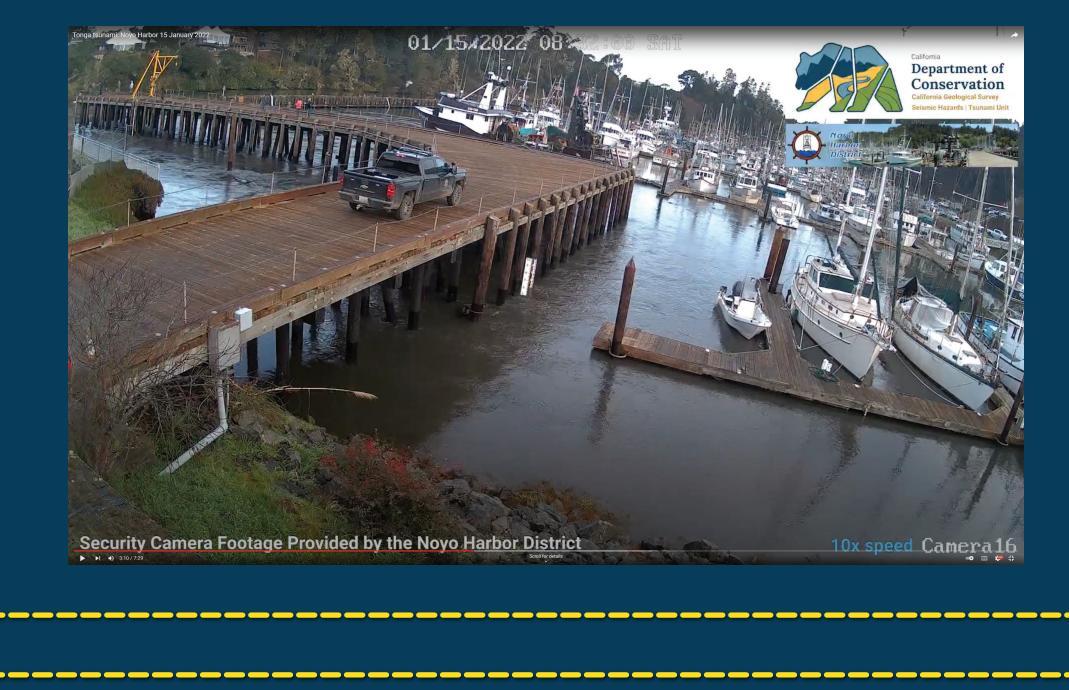
--• Novo Harbor

There is no active tide gage in Noyo Harbor (Fort Bragg). However, the Anna Neumann (NH Harbor Master) provided security video. There is a staff plate attached to a piling in the view of the video camera. CGS and Cal OES staff use a U.A. Army Corps of Engineers benchmark to provide a vertical reference for this staff plate. Using tidal datum analyses from a NOAA tide gage installed in the 1970s, the staff plate reference elevation is placed into a MLLW reference frame. Using the video footage, CGS staff here prepare a marigram for this location in Noyo Harbor. CGS staff use the NOAA tidesandcurrents tidal forecast to calculate the amplitude. This video referenced marigram is shown below.

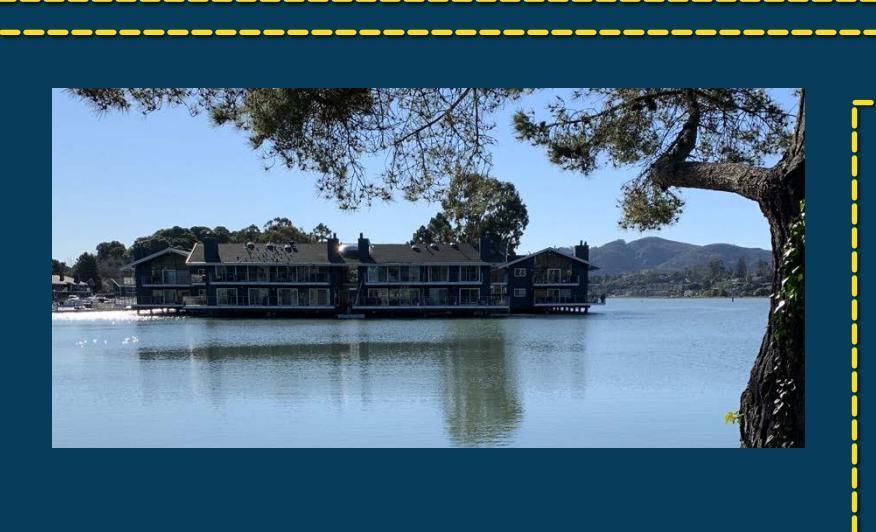
-- Strawberrv Damage to floating dock as it was ripped away during the tsunami.

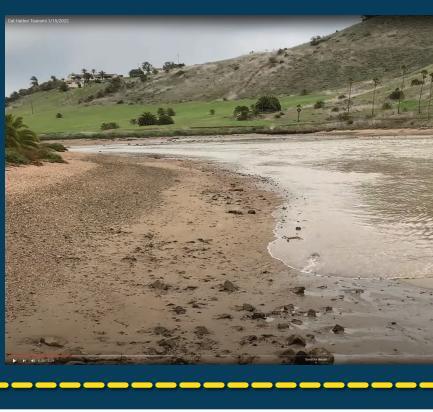
--• Cat Harbor, Catalina

At Cat Harbor, the western side of Two Harbors, there were strong currents and cm scale tsunami waves recorded on videos posted online. The screenshots from

https://www.youtube.com/watch?v=3RZtmbPxLzQ were recorded aroud 2pm localt time.

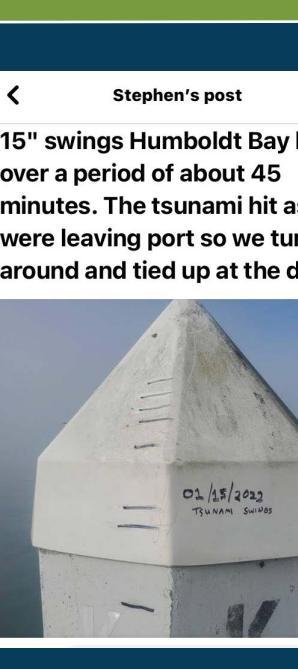
----• Humboldt Bay

The Tsunami in Humboldt Bay was ob served by members of the Humboldt Bay Yacht Club. Here are some marks that Stephen Buck made during the tsu nami. The wave height in the marina was less than that observed at the North Spit Tide Gage, which is closer t the bay entrance.
