M 7.5, 219km SSE of Severo-Kuril'sk, Russia

Origin Time: 2020-03-25 02:49:21 UTC (Wed 13:49:21 local)

Location: 48.9864° N 157.6933° E Depth: 56.6 km

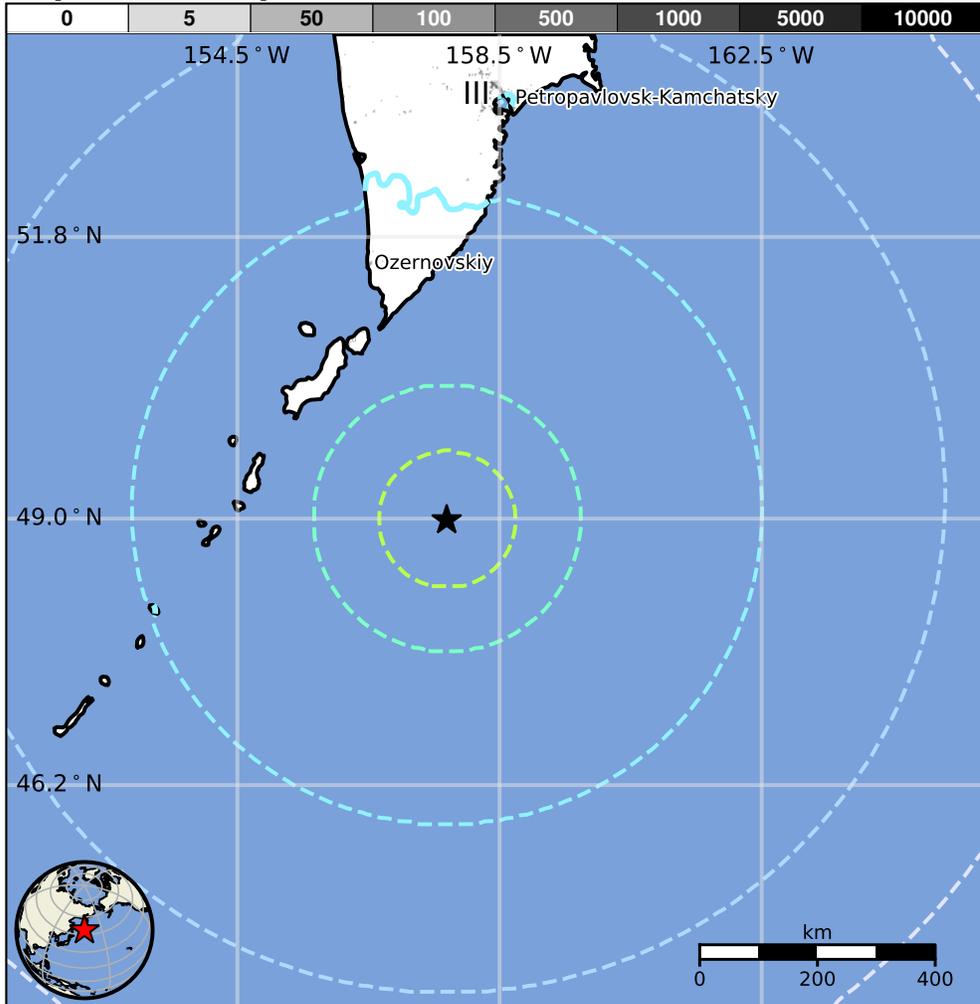
Population Exposure

ESTIMATED POPULATION EXPOSURE (k=x1000)		—*	83k	192k	0	0	0	0	0	0
ESTIMATED MODIFIED MERCALLI INTENSITY		I	II-III	IV	V	VI	VII	VIII	IX	X+
PERCEIVED SHAKING		Not felt	Weak	Light	Moderate	Strong	Very Strong	Severe	Violent	Extreme
POTENTIAL DAMAGE	Resistant Structures	None	None	None	V. Light	Light	Moderate	Mod./Heavy	Heavy	V. Heavy
	Vulnerable Structures	None	None	None	Light	Moderate	Mod./Heavy	Heavy	V. Heavy	V. Heavy

*Estimated exposure only includes population within the map area.
